Gandsfjorden Geophysical and Geotechnical Survey

Marine Survey Report

Statnett

Document No: 101755-STN-MMT-SUR-SURVEYRE
Statnett Reference no.: SN2014_05

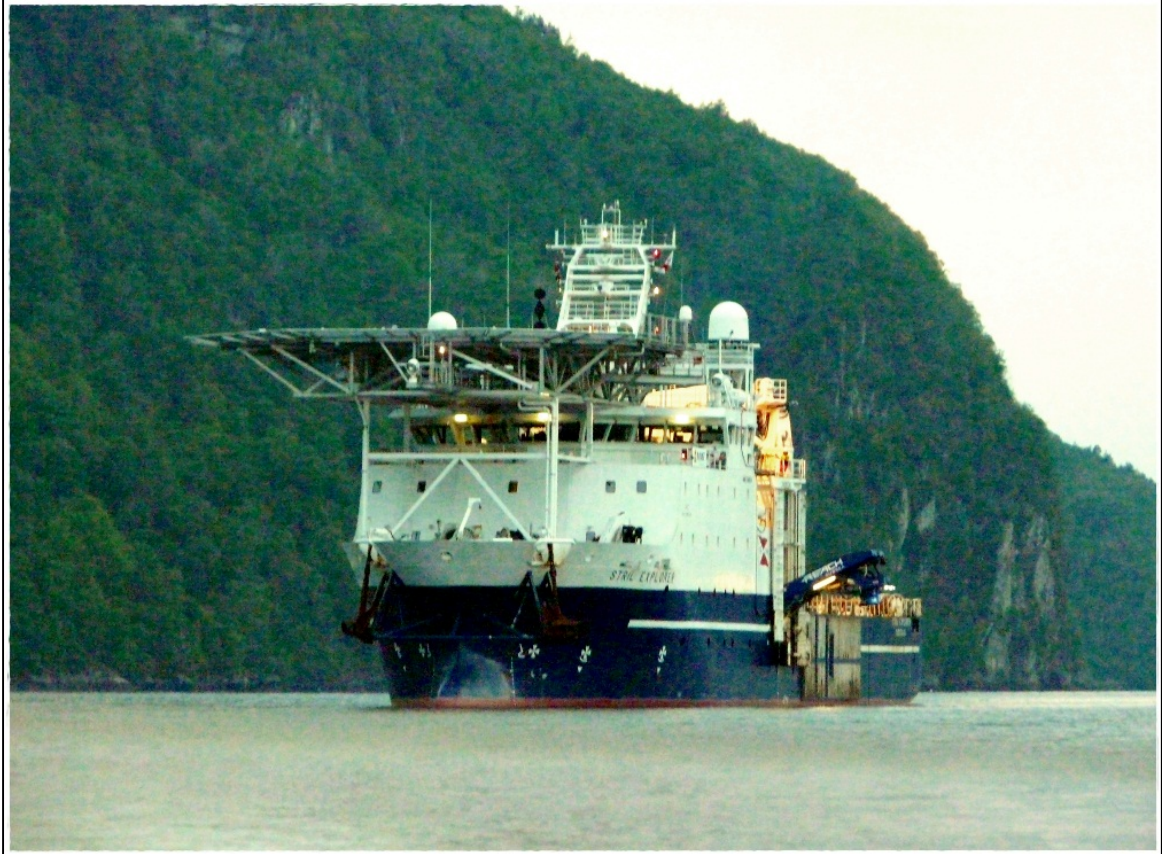
Figure 4 M/V Stril Explorer

The vessel M/V Stril Explorer is shown in Figure 4 and a short summary of vessel specification are given here.

Port of Registry:	Douglas
Flag:	Isle of Man
Call sign:	2EBI9
Class:	Det Norske Veritas + 1A1 General cargo Carrier EO-HELDK-S-DYNPROS-AUTR
Builder:	Westcon, Norway
Date of build:	2010
LOA:	76.4 m
Draught:	4.75 m
Machinery:	4xCat 3516
Service speed:	10-12 knots

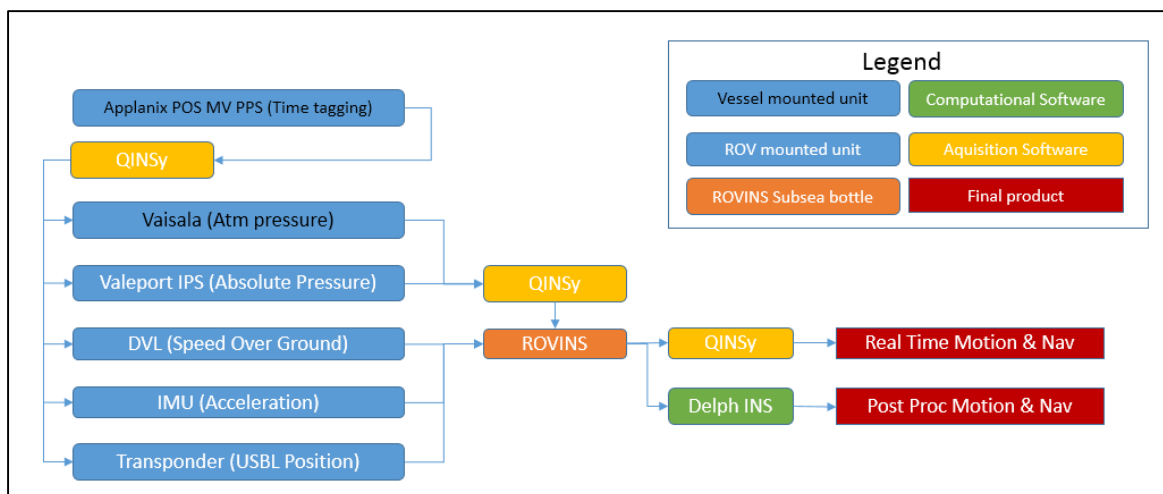
A schematic view of the underwater positioning system is shown in Figure 5. The iXSEA ROV INS as a central unit receives and records data from a number of sources. Each individual data type is there after stored within one binary file, which through post processing in the iXSEA Delph INS software may be individually prioritized depending on observed accuracy.

Figure 5 Schematic view of the underwater positioning integration.

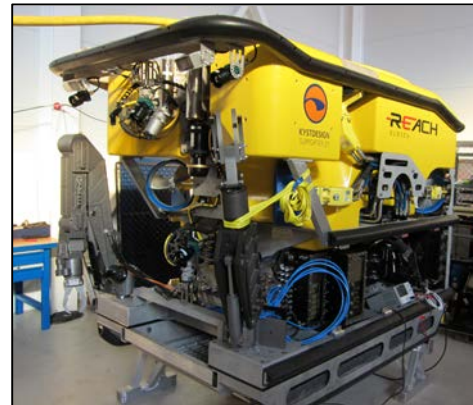
Depth rating	2000 msw
Mass	2450 kg
Length	2500 mm
Width	1700 mm
Height	1650 mm
Through-frame lift	3000 kg
Payload in seawater	220 kg
Power	125 Hp
Thrusters	4 x horizontal, 3 x vertical
Speed forward	3 knots

Figure 6 Supporter ROV

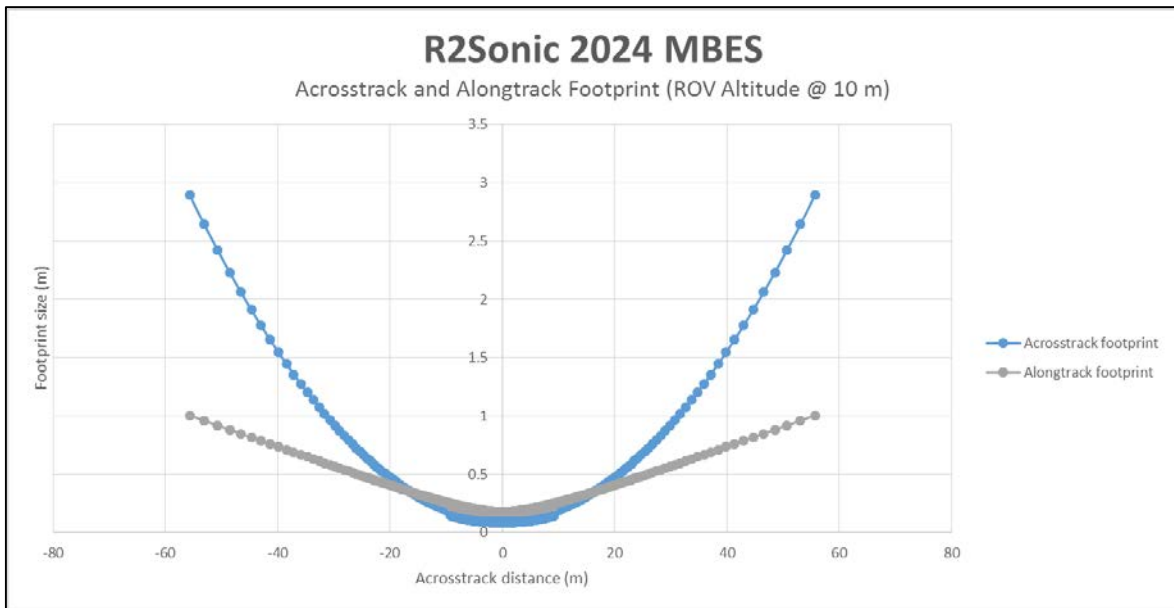
The coverage and resolution of the acquired MBES data allowed producing a 0.2 m DTM, with a mean of 14 soundings per grid cell. The MBES footprint is illustrated in Figure 8. Multiple wrecks and man-made objects as well as many scars in the seabed are visible in good detail. Steep slopes in the eastern part of the fjord presented a challenge for steady flight of the ROV and affected the stability of the acquired data. Thanks to several infill passes recorded from a higher altitude, gaps in the crucial areas were filled in.

Figure 8 The MBES footprint at a height of 10 m above seabed.

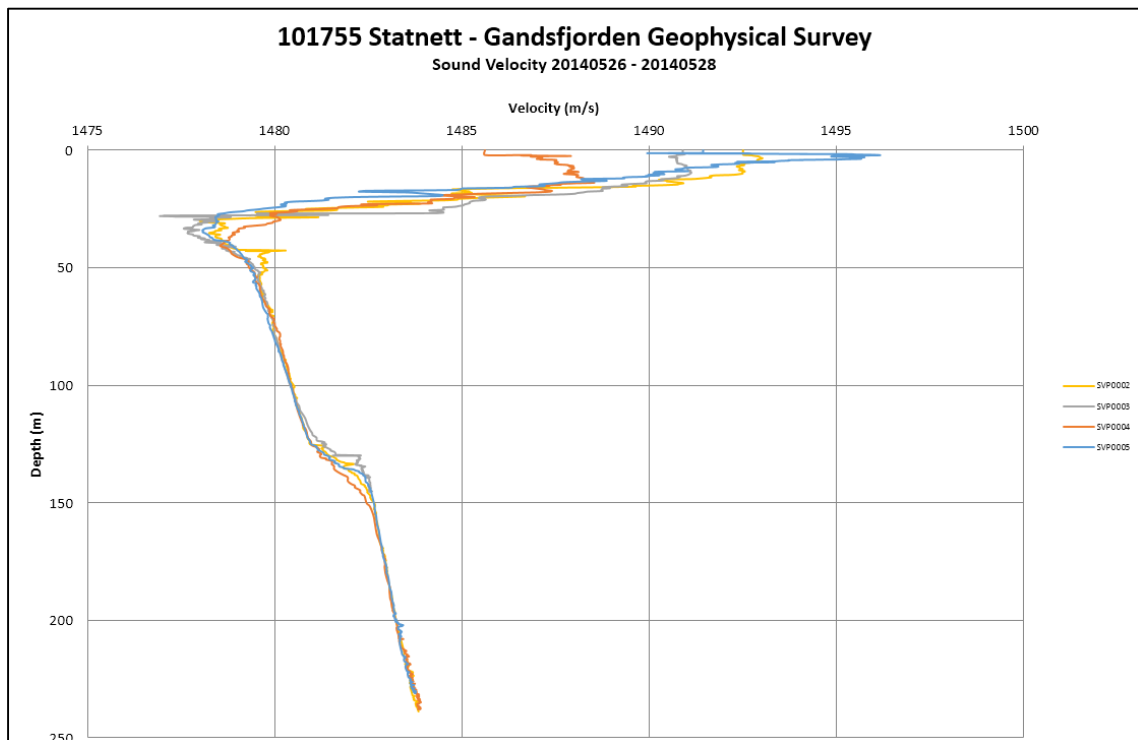
In total four sound velocity profiles (SVP) were acquired during survey operations in Gandsfjorden. The diagram below indicates a relatively well mixed water column with a pycnocline visible at a depth of approximately 30 to 40 m.

Figure 10 Sound velocity diagram displaying SVPs acquired in Gandsfjorden

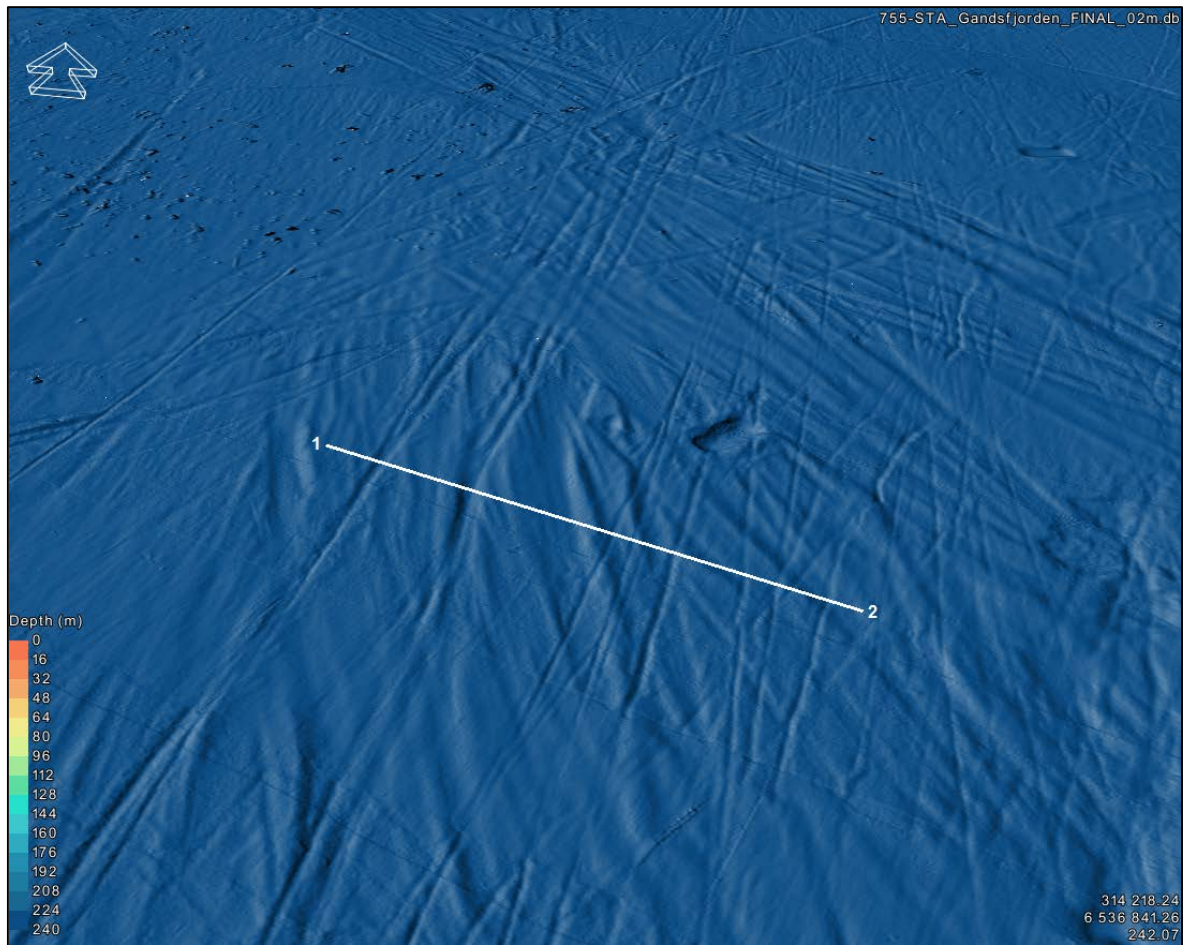
Figure 17 Bathymetric image and profile across seafloor scars in the central deep section of the fjord. The scars are approximately 20-40 cm in depth. (Heading 354 deg, Pitch 55 deg)

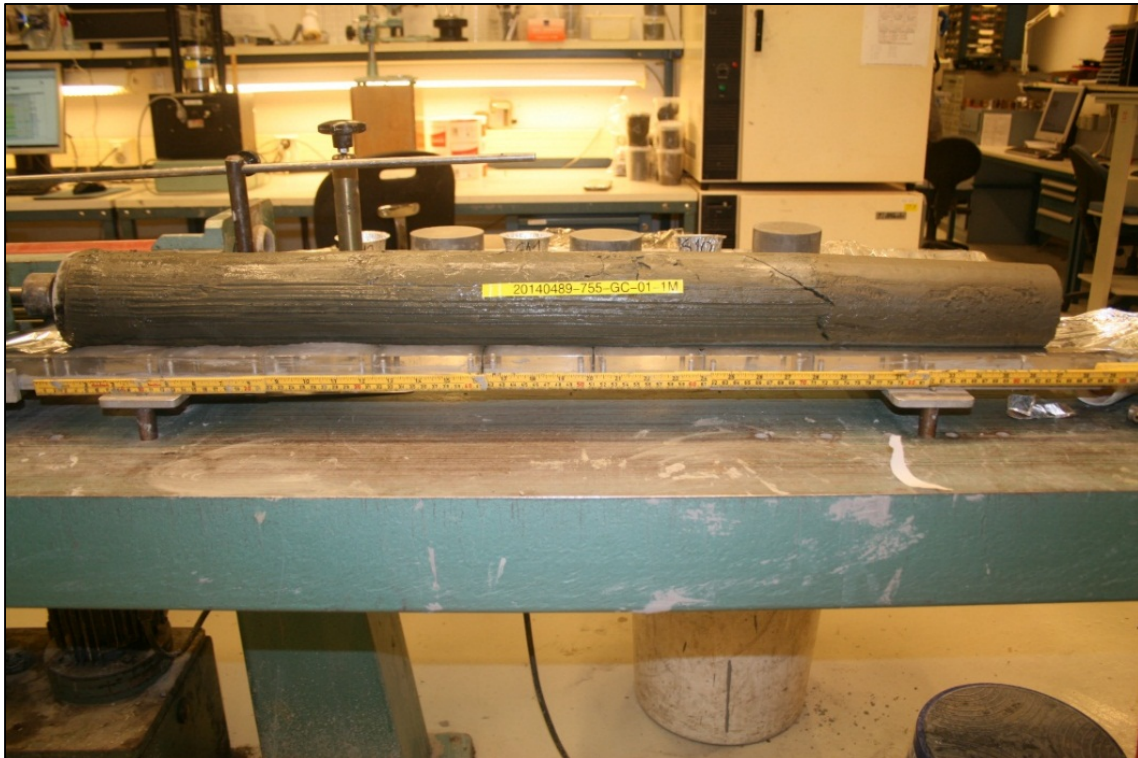
Figure 27 Gravity corer sample 755-GC-01 at the laboratory.

This Gravity Corer sample (Figure 27) consisted of extremely soft, generally very slightly sandy, silty GYTTJA CLAY and CLAY with sulphuric odour, indicating anoxia. Shell fragments are present in the upper metre of the sample. The mean thermal resistivity in this sample was 0.81 W/mK.

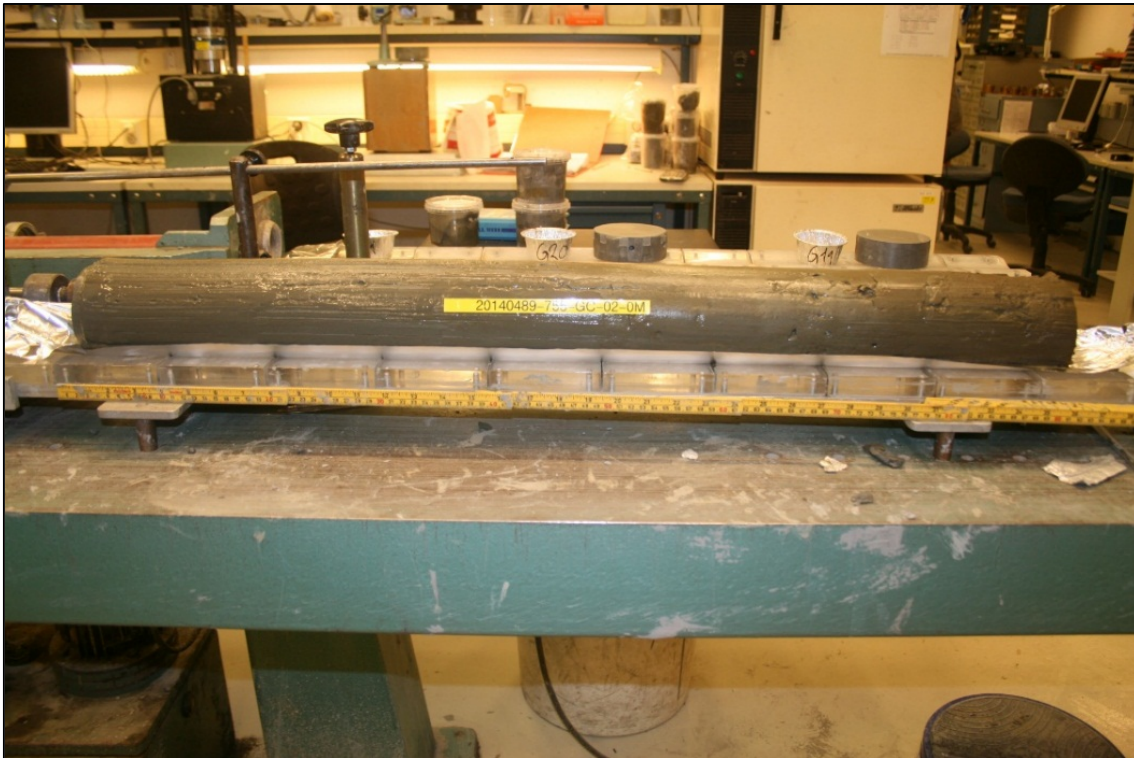
This Gravity Corer sample (Figure 28) consisted of silty sandy CLAY on top of extremely soft very slightly sandy, silty CLAY. In the top metre organic content, cobbles and pebbles were observed. Shell fragments were present between 1-2 m. The mean thermal resistivity in this sample was 1.01 W/mK.

Figure 28 Gravity corer sample 755-GC-02 at the laboratory.

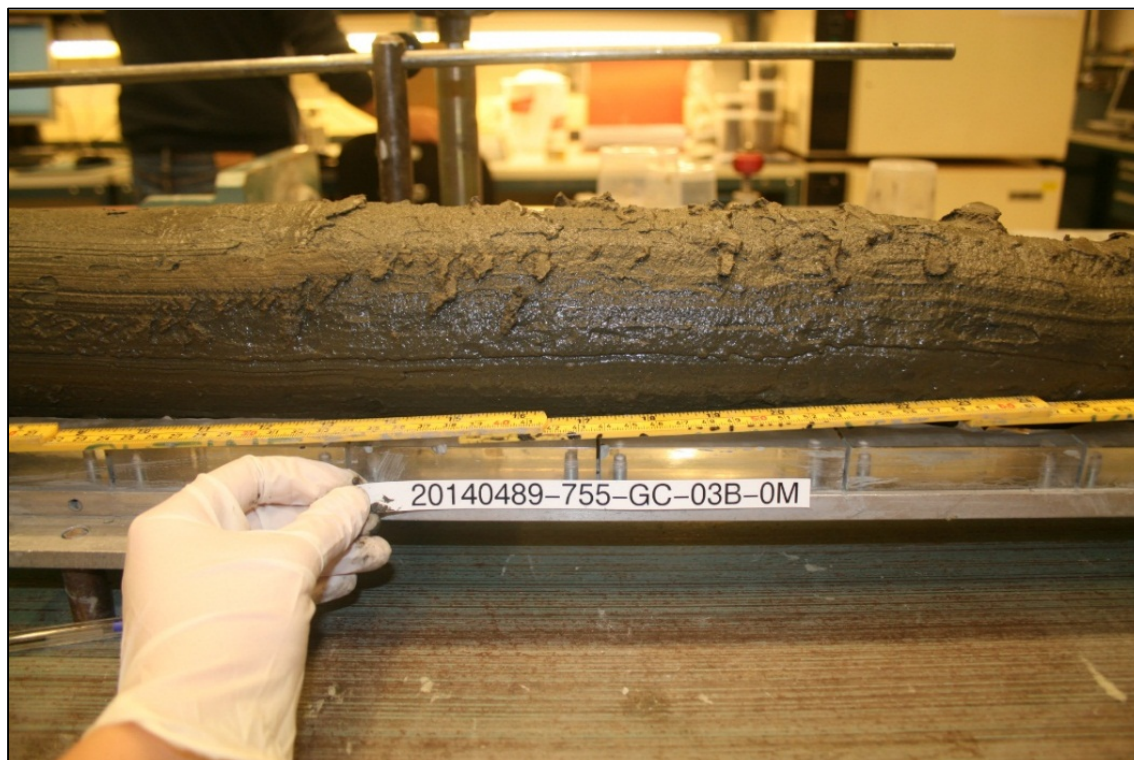
Figure 29 Gravity corer sample 755-GC-03 at the laboratory.

This Gravity Corer sample (Figure 29) consisted of primarily very soft silty CLAY with some sandy, silty GYTTJA in the uppermost part. The sample had a sulphuric odour indicating an anoxic environment. The mean thermal resistivity in the sample was 0.84 W/mK.

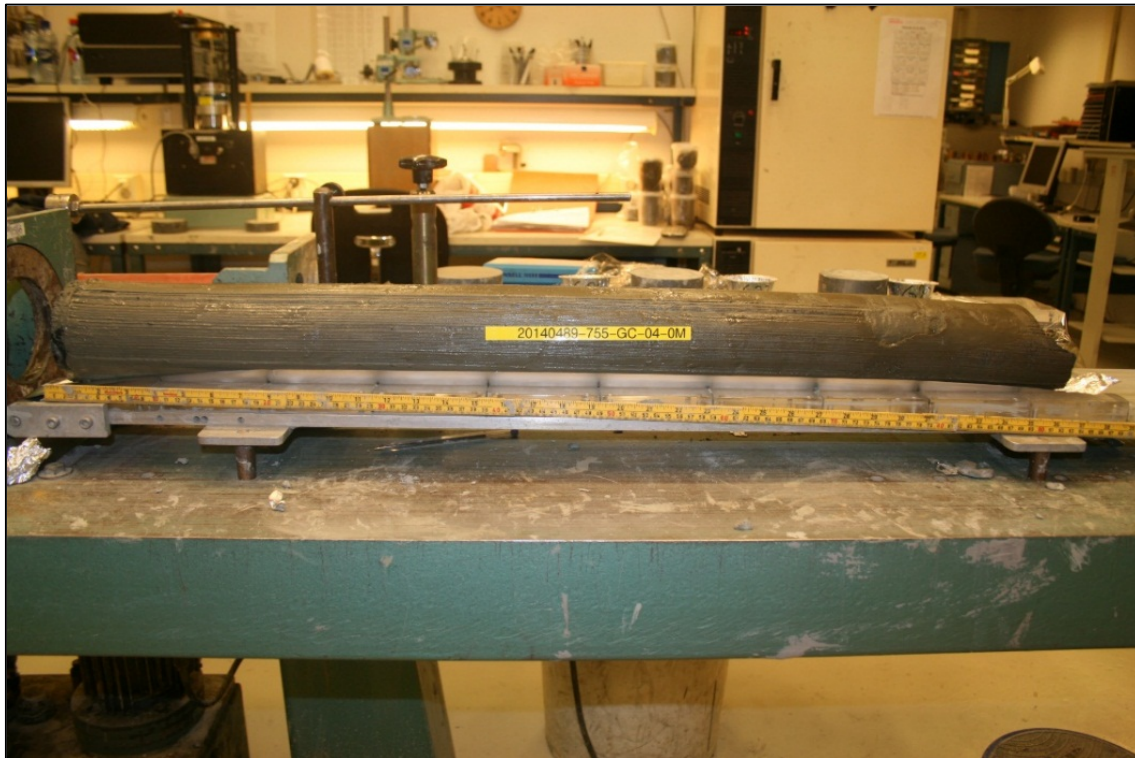
Figure 30 Gravity corer sample 755-GC-04 at the laboratory.

This Gravity Corer sample (Figure 30) consisted of very soft sandy, silty CLAY with sandy, clayey SILT with stones and shell fragments in the uppermost part. The mean thermal resistivity in this sample was 1.06 W/mK.

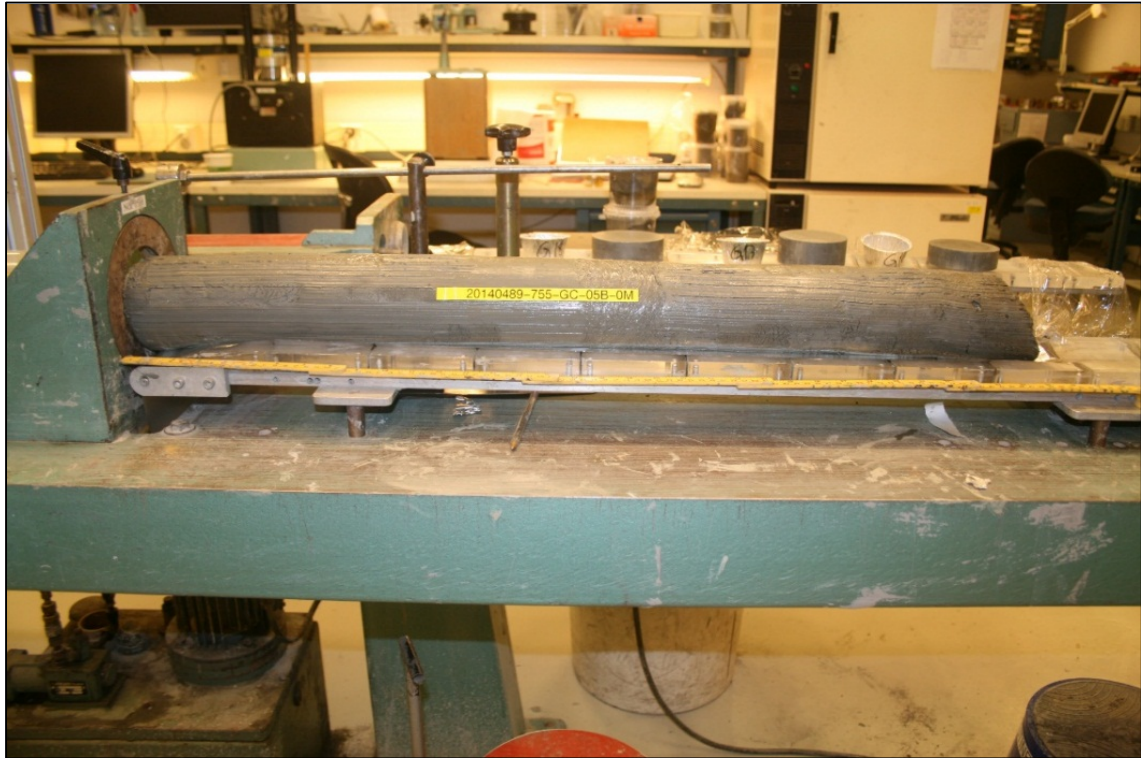
This Gravity Corer sample (Figure 31) consisted of slightly sandy, silty CLAY with gravelly, silty sandy CLAY in the uppermost part, where also Cobbles, SAND pockets and shell fragments were observed. The mean thermal resistivity in this sample was 1.60 W/mK.

Figure 31 Gravity corer sample 755-GC-05 at the laboratory.

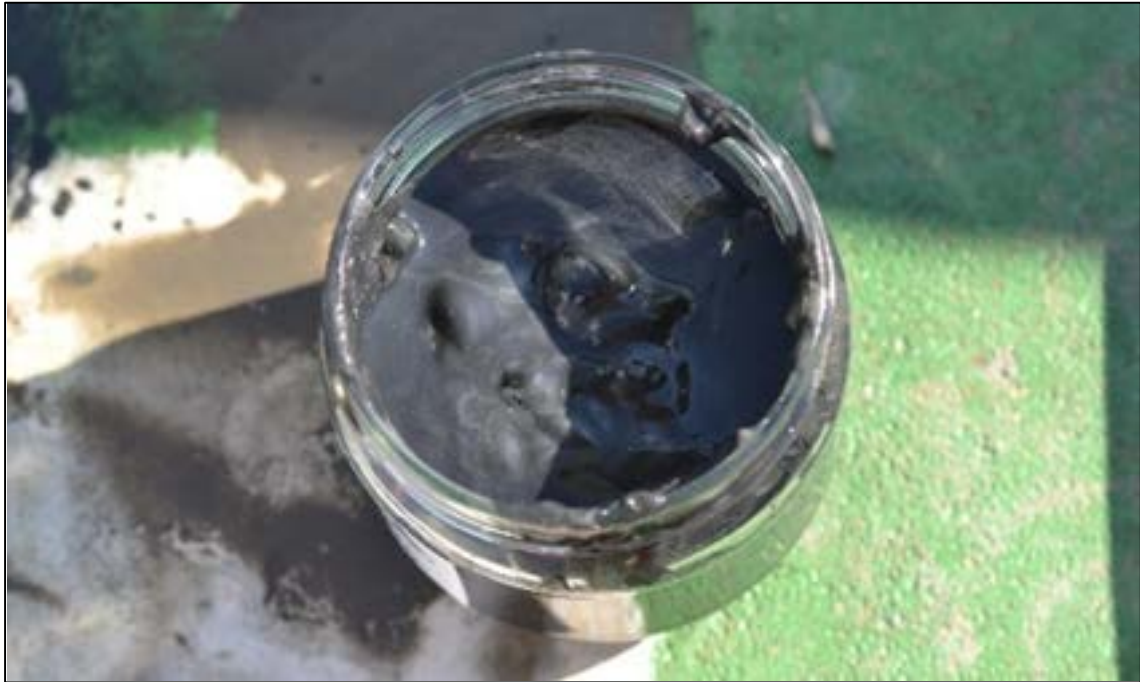
Figure 33 Push corer sample 755-PC-07 in field.

This Push Corer sample (Figure 33) consisted of slightly clayey, slightly sandy SILT. It was tested for chemical content at ALS laboratory and generally showed concentrations above average of heavy metal and organic contaminants, generally klasse II and III, (Weideborg, et al., 2013). The sample showed significant increase in Copper (Cu) concentration (klasse IV). (Weideborg, et al., 2013).

Sampling for chemical analysis were achieved with a push corer (PC), operated by the ROV. In total three samples were collected and sent to laboratory for analysis. The chemical content in all three samples generally showed concentrations above average of heavy metal and organic contaminants, generally klasse II and III, (Weideborg, et al., 2013). Two of the samples showed significant increase in Copper (Cu) concentration (klasse IV). (Weideborg, et al., 2013).

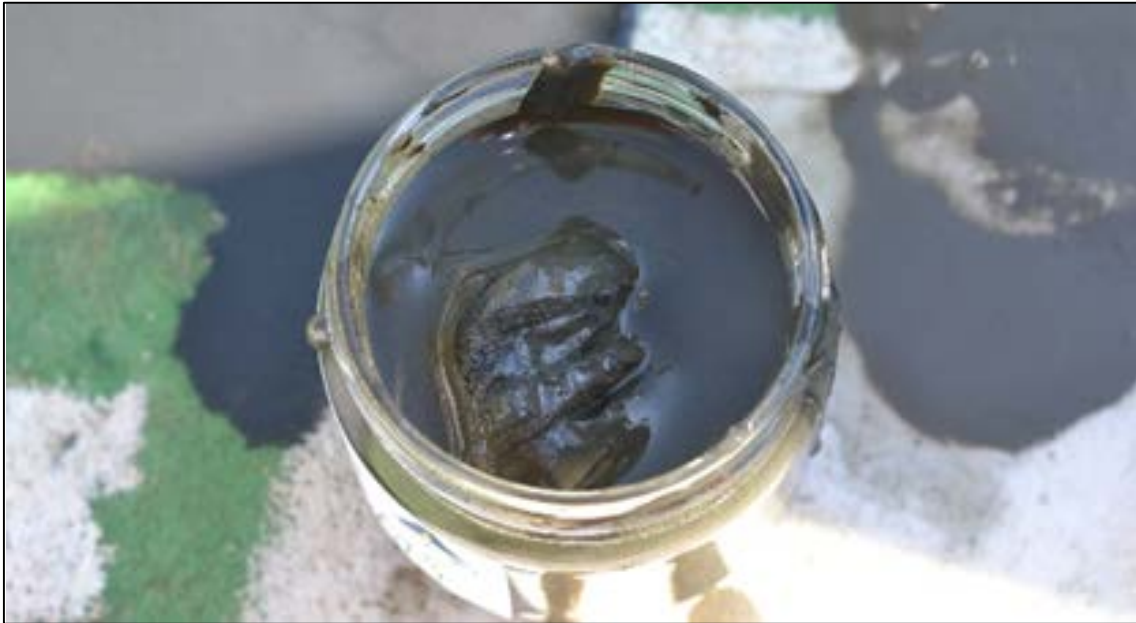
Figure 34 Push corer sample 755-PC-08 in field.

This push corer sample (Figure 34) consisted of very slightly clayey, slightly sandy SILT. It was tested for chemical content at ALS laboratory and generally showed concentrations above average of heavy metal and organic contaminants, generally klasse II and III, (Weideborg, et al., 2013). The sample showed significant increase in Copper (Cu) concentration (klasse IV). (Weideborg, et al., 2013)

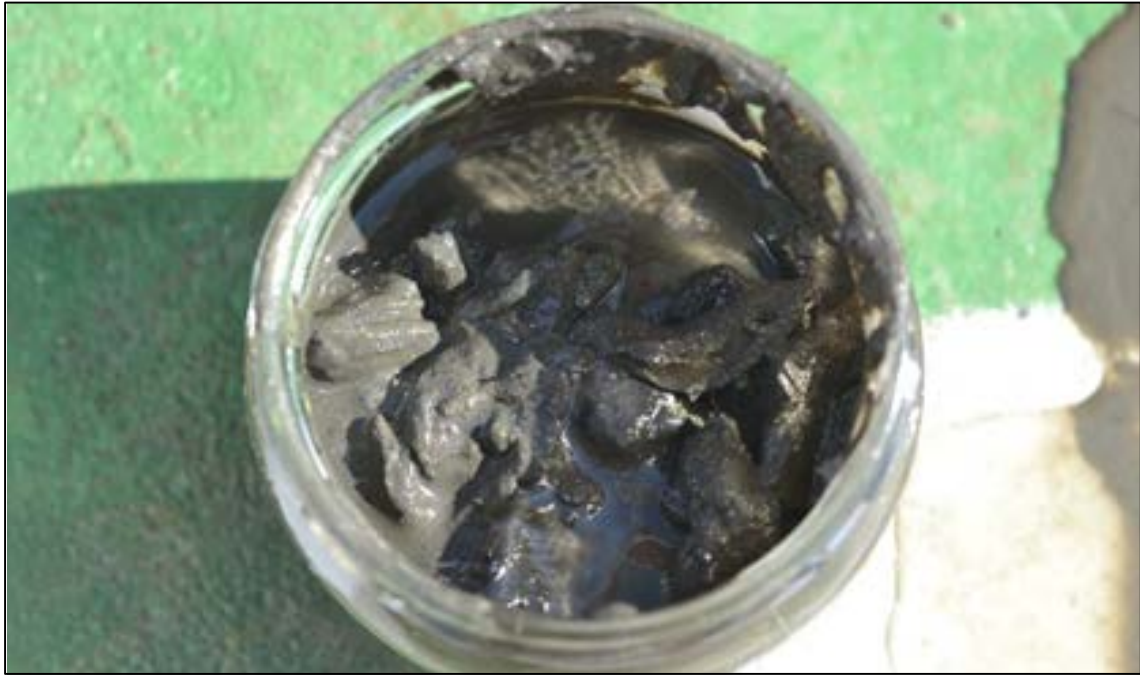
Figure 35 Push corer sample 755-PC-11 in field.

This push corer sample (Figure 35) consisted of very slightly clayey, sandy SILT. It was tested for chemical content at ALS laboratory and generally showed concentrations above average of heavy metal and organic contaminants, generally klasse II and III, (Weideborg, et al., 2013).

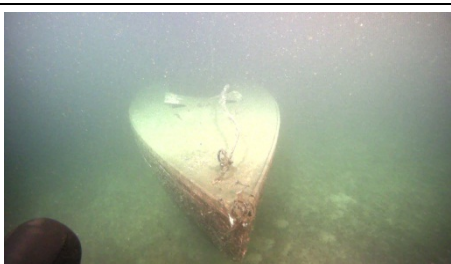
GF-R-0002	314555	6536668	Wooden Wreck

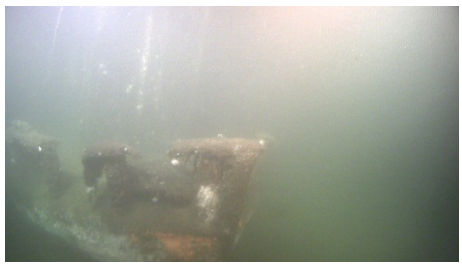
Contact ID	Easting	Northing	Comment	Image
GF-R-0113	314584	6536868	Small fishing boat

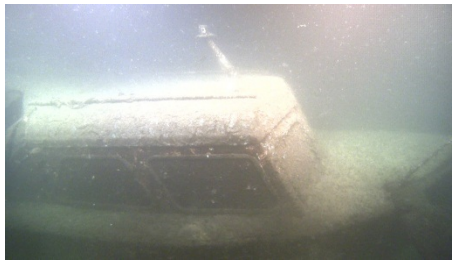
GF-R-0394	314476	6536895	Small Boat

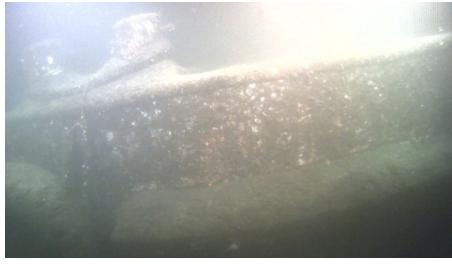
GF-R-0112	314003	6537154	Possible tug boat

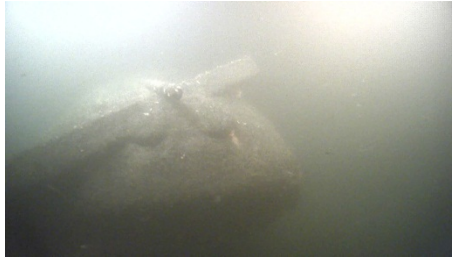
GF-R-0381	314138	537231	Metallic wreck

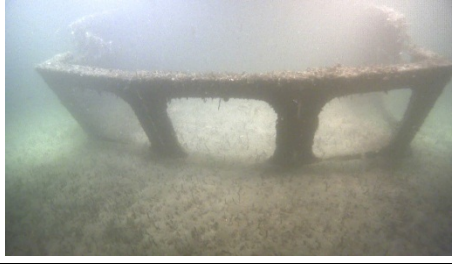
GF-R-0389	314113	6537265	Modern small boat

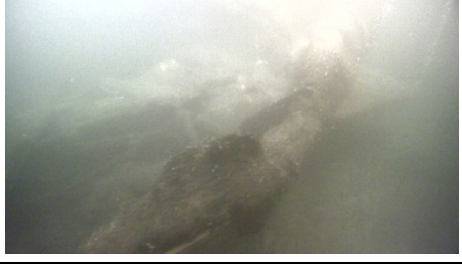
GF-R-0346	314171	6537379	Small craft
